Source Control Evaluation Operable Unit 1 Swan Island Upland Facility Portland, Oregon

Prepared for: Port of Portland

February 20, 2013 1115-06

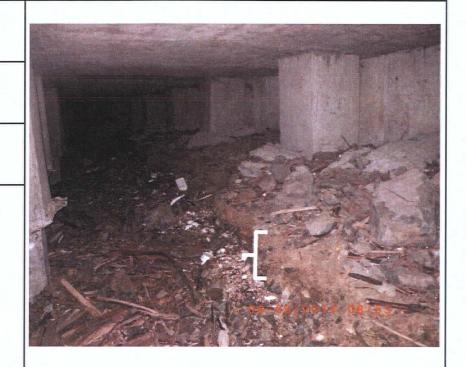
Feature Z - White bracket highlights scarp face.

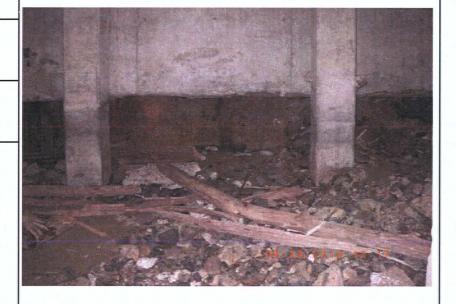
2

Vicinity of Feature X showing exposed sheet-pile bulkhead wall.

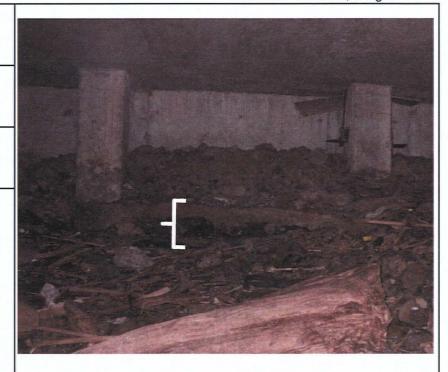
Feature S - White bracket highlights scarp face.

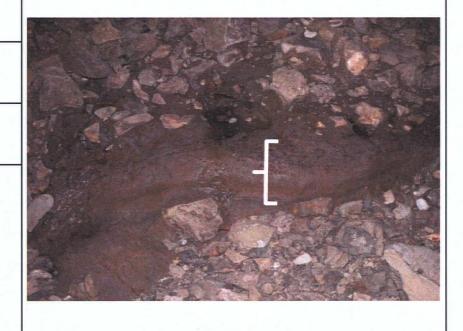
4

Feature O - White bracket highlights scarp face.

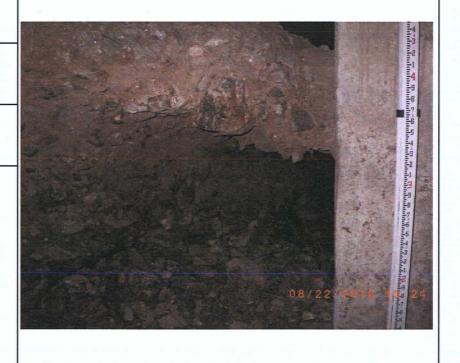
6

Feature C - Close-up of scarp face. Height is 3.3 feet on

survey rod.

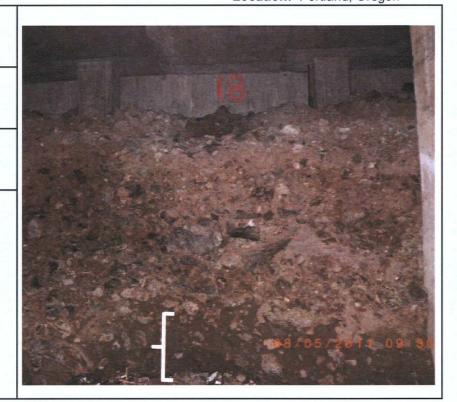
Feature B - White bracket highlights vertical portion of

scarp face.

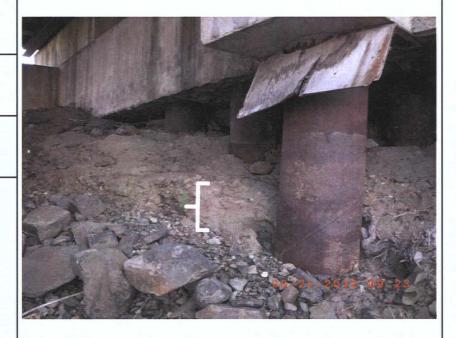
8

Feature AC - White bracket highlights scarp face.

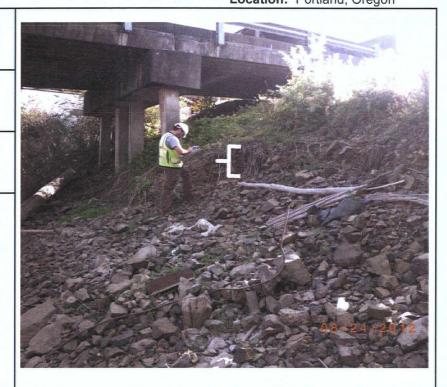
Feature AD - White bracket highlights scarp face.

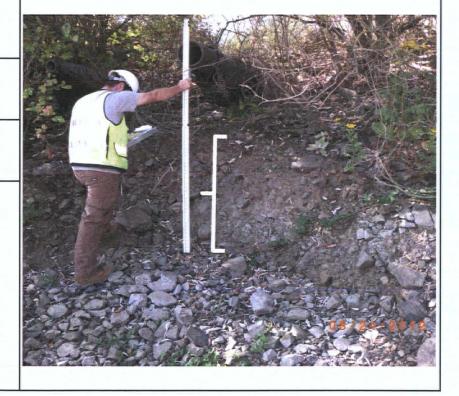
14

Feature AL - White bracket highlights scarp face.

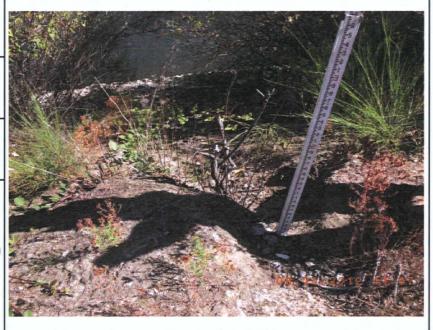
Feature AN - Example of erosion rill on riverbank slope.

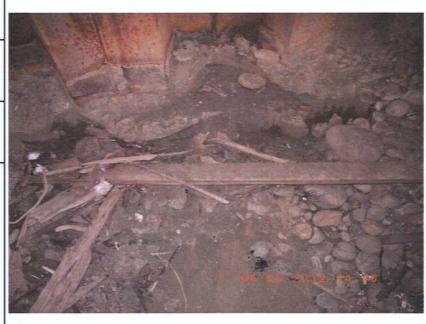
Photo No: 16

Typical location with thin layer of sand present on and surrounded by rip-rap. Attributed to deposition during periods of high water. See also Photographs 17 and 19).

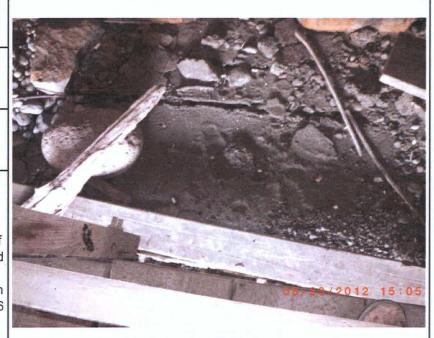
Typical location with thin layer of sand present on and surrounded by rip-rap. Attributed to deposition during periods of high water. See also Photographs 16 and 19).

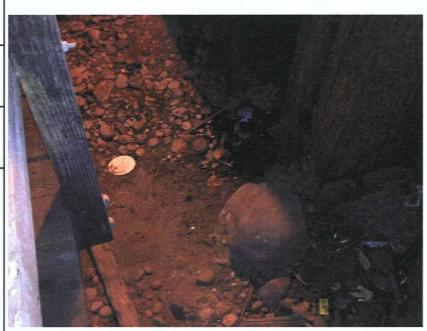
Typical location with thin layer of sand present on and surrounded by rip-rap. Attributed to deposition during periods of high water. See also Photographs 16 and 17).

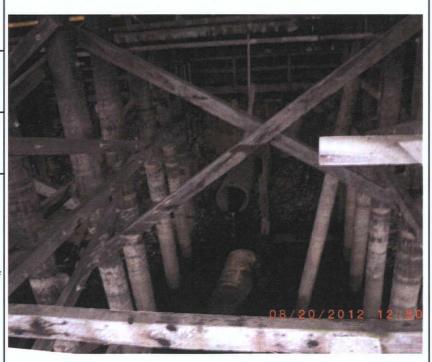
Photo No: 20

Feature AQ - Taken from outer catwalk. Disconnected section of outfall pipe in bottom center of photograph. See photographs 21 and 22.

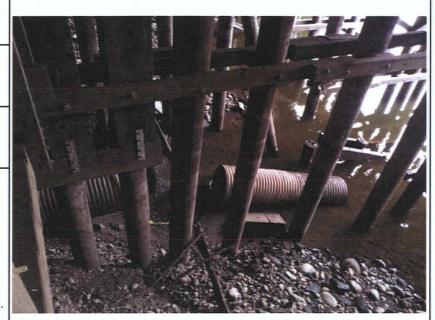
Feature AQ - Taken from inner catwalk. Disconnected section of outfall pipe in center right of photograph. Note small cove corresponding to outfall location.

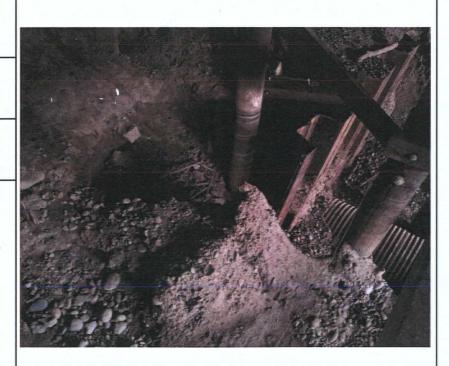
22

Feature AQ - Taken from inner catwalk. Scarp and bare soil upslope of outfall pipe around sheet pile wall.

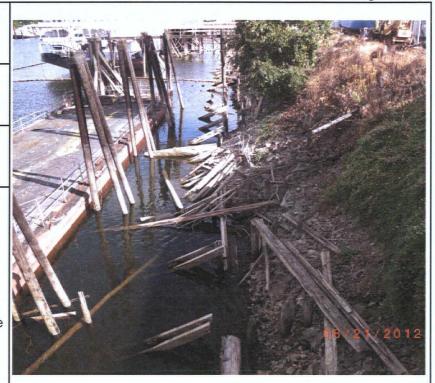
Feature AU - This feature is located under the outfall pipe in the upper right of the photograph. A section of this outfall pipe was observed on the riverbank further east.

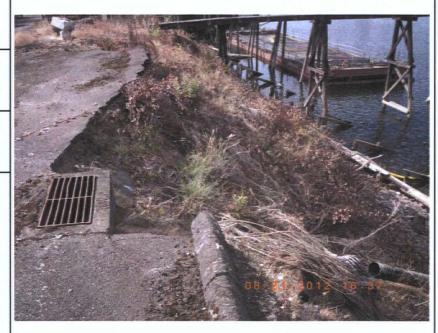
28

Feature AY - Erosion along top of riverbank as indicated by rough edge of asphalt-concrete adjacent to catch basin. Note the segments of the outfall pipe that are disconnected in the lower right of the pthotograph. See also photograph 29.

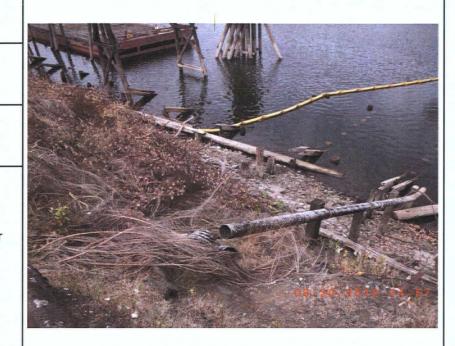
Feature AY - Riverbank under disconnection segments of outfall pipe.
